## Appendix F: Corridor Existing Conditions

### F1. Existing Roadway Conditions

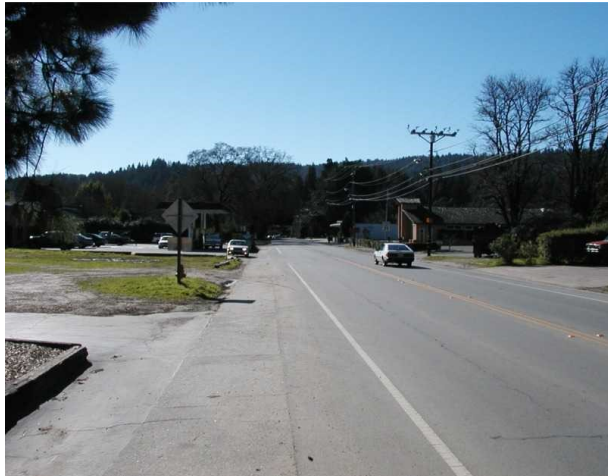
**Southern sections of Hwy 9**

These areas have at least 8' shoulders with adjacent unobstructed area for pedestrians, or shoulders wide enough to be designated as Class 2 bike lanes (4' to 6') and existing sidewalk or paved pedestrian path. Some barriers such as utility poles, trees, signs, and driveways would have to be addressed to complete or formalize these improvements. This condition often occurs in or near the center of the business districts.

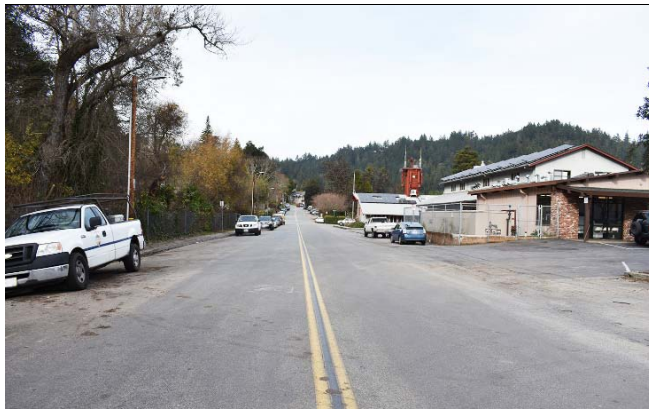
**Felton**

Typically, on at least one side, there is room to widen the highway and/or construct a separate pedestrian path with some minor grading and drainage structure addition/improvement, though some barriers such as utility poles, drainage ditches, trees, and driveways would have to be addressed. This condition generally occurs on the outskirts of the towns.

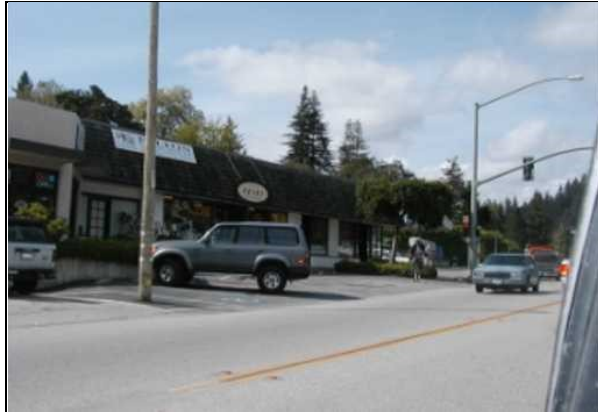
**Central Felton**

This type includes residential or commercial areas where the structures, parking, and improvements have been established close to the roadway, or State Park or other areas where mature trees (typically redwoods) are adjacent to the roadway, so that widening the highway, providing a separate Class 1 trail, or providing a sidewalk or path would require redesign or re-arrangement of the site. A common condition is conflict with residential, or more commonly commercial parking that uses the highway right-of-way for head-in and pull-out.

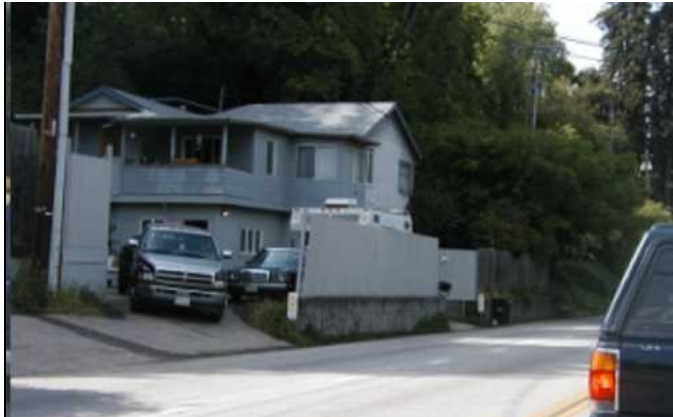
**Hwy 9 north of Graham Hill Road, looking north**

This condition occurs north of Graham Hill Road and in other locations in the corridor. Here there are significant construction requirements, such as new or added retaining walls, plus significant potential impact on adjacent structures, trees, driveway access, etc. that would constrain widening or adding pedestrian facilities.

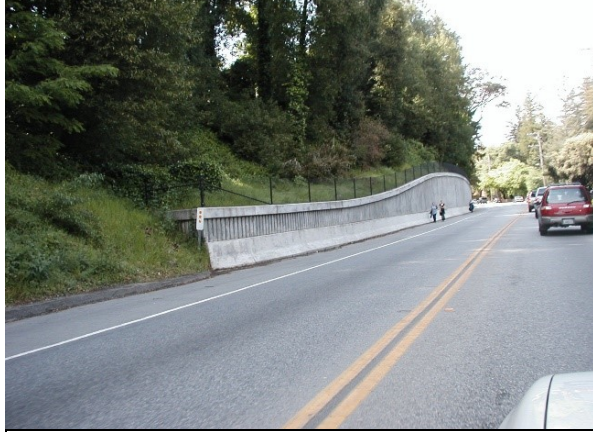
***Between Felton and SLV Schools Campus***

In these areas the highway surface is many feet above or below the top of the adjacent slope. Creation of additional room to widen or add a trail would require the complete reconstruction of the wall or addition of a parallel structure to support the trail.

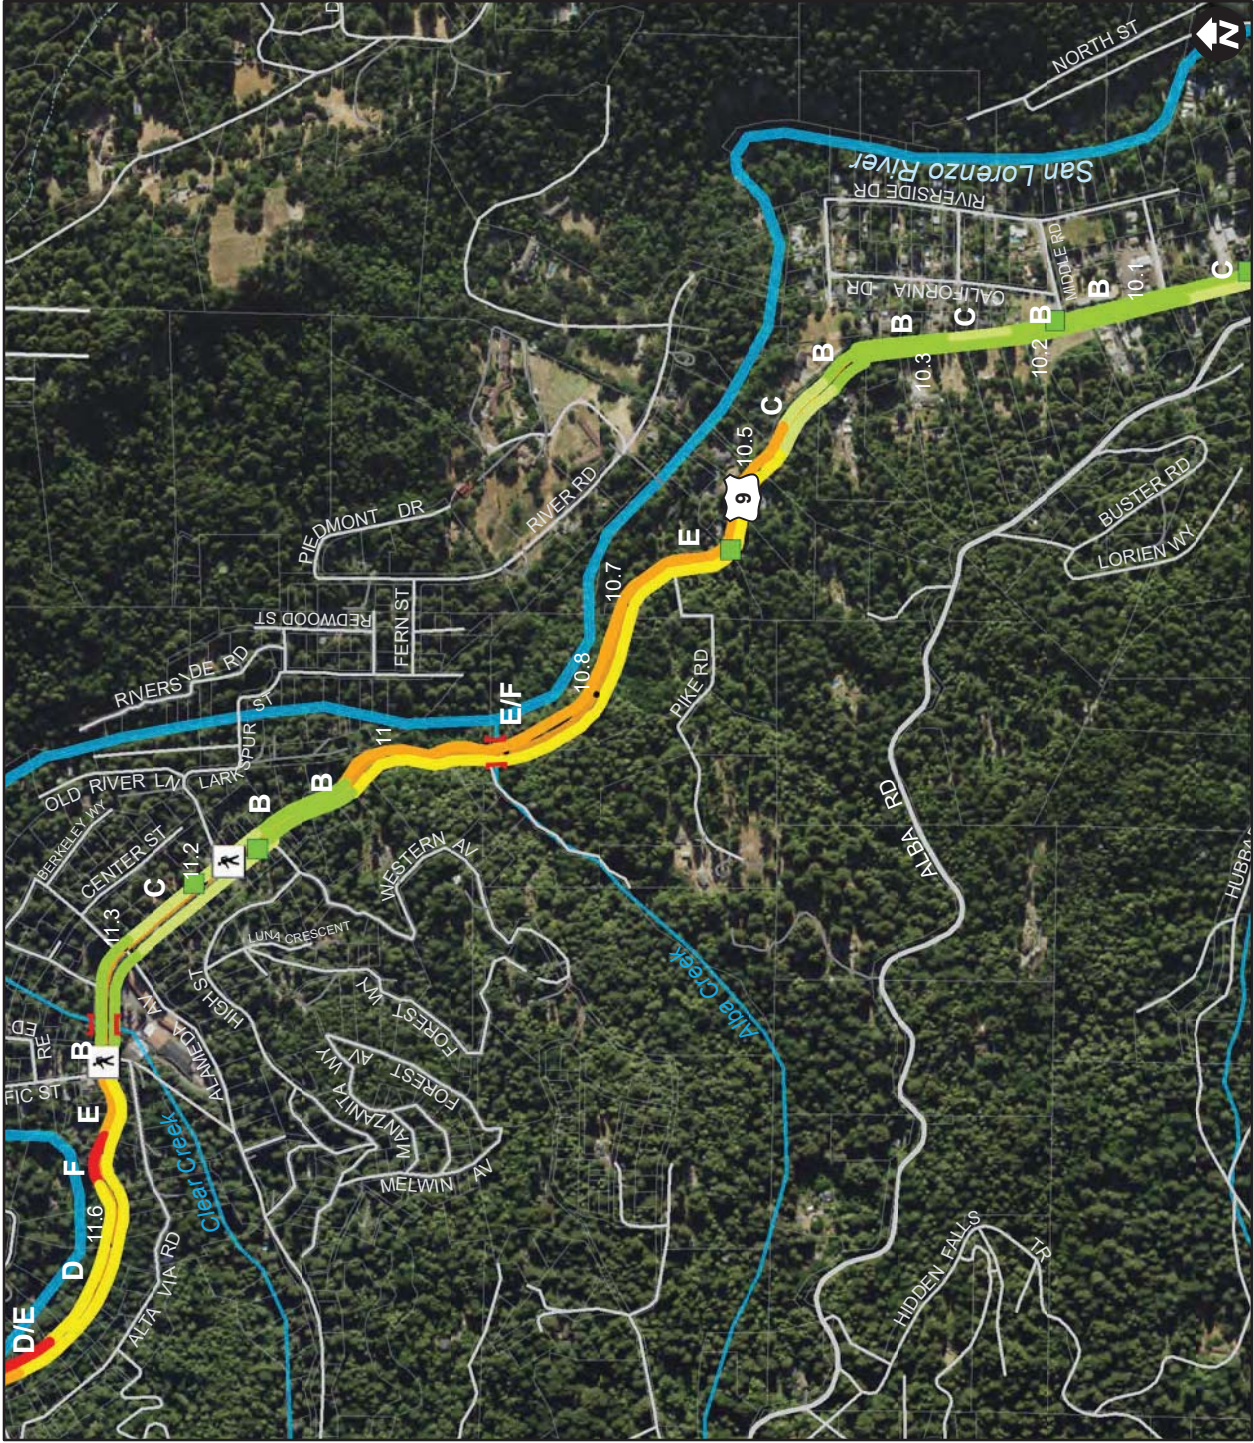
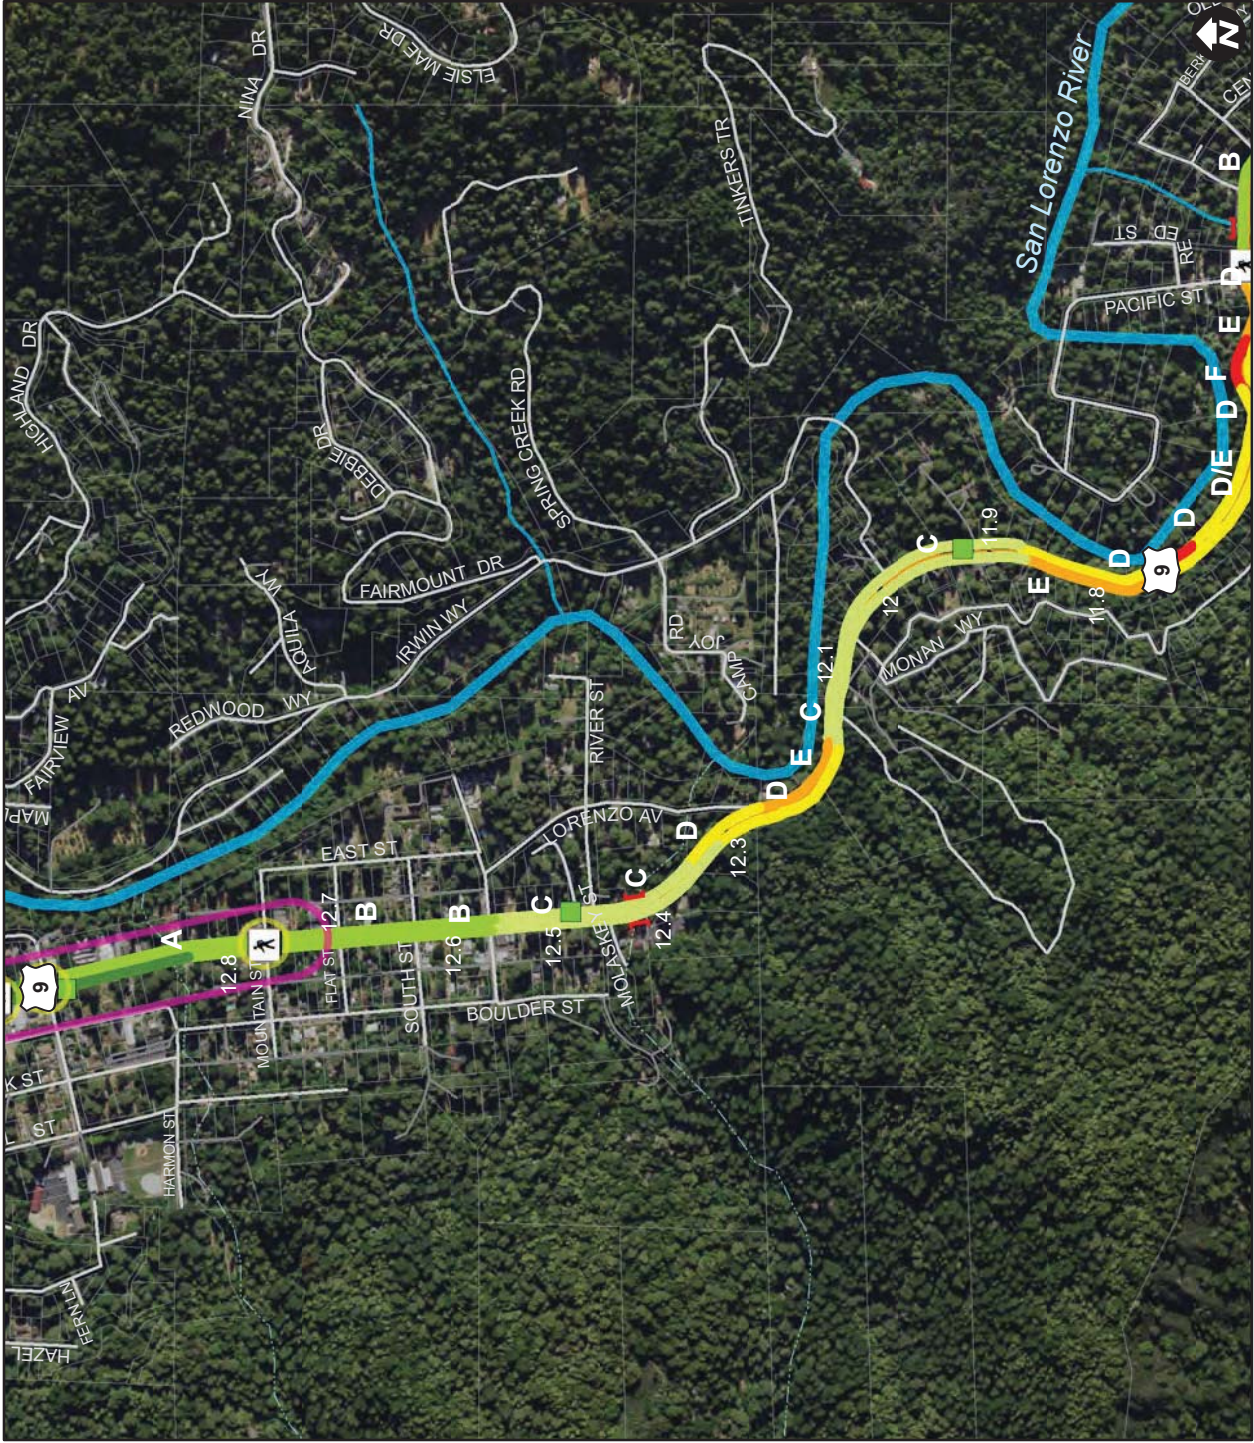
Figure F3: Bicycle and Pedestrian Conditions Maps

A Complete Streets study typically looks to better balance accommodation of motorists and accommodation of bicyclists and pedestrians. For the purpose of this study the following categorizes existing conditions along the routes and constraints for providing more space for bicyclists and pedestrians. Similar to traffic level-of-service descriptions, they are organized A to F, with “A” representing areas where access space or facilities are decent (though perhaps not ideal), and “F” being the most constrained condition for adding bicycle or pedestrian improvements or other improvements that require additional space (i.e. turn lanes or bus stops). These condition categories are described in the following pages. **Figure F3** maps where these varying conditions exist through the corridor.
